CHAPTER 4.

HEALTH-IMPACTING BEHAVIORS AT THE HOUSEHOLD LEVEL, AND THE INTERSECTION OF HOUSING AND HEALTH AND WELLBEING.

(Primary Chapter Authors: Andrea Sandoval & Peter Ward with Melannie Ruiz)

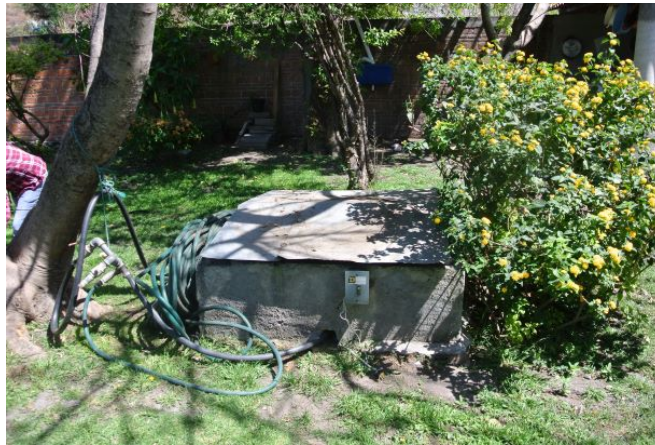
Photograph 4.1: Typical Well in Santa Ana Coatepec (Image taken by Dr. Peter Ward)

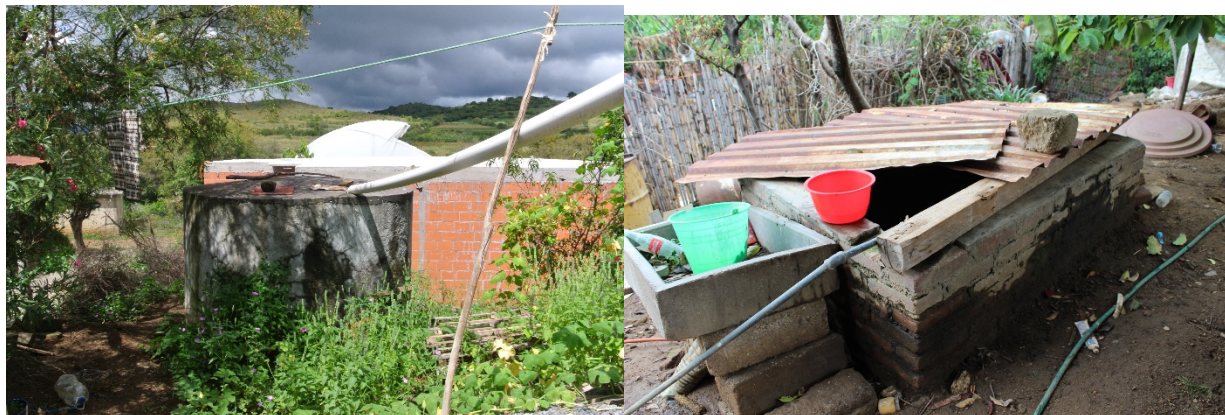
Photograph 4.2 (left): Roof-fed Rainwater to Storage Tank SFX. Photograph 4.3 (right): Water storage tank in San Fco. Xochiteopan. Note the feeder in-pipe, as well as buckets to scoop water for washing etc. (Images taken by Dr. Peter Ward).

The water cistern (see Photograph 4.2 earlier), is fed from the tap supply and is used both for drinking and for watering the animals. While not fetid, the water clearly was not fit for human consumption (insects etc.): if used as a drinking source it would be a health hazard.

The pipes and hoses leading to and from the cistern impede mobility and present a danger to mobility and may cause falls. Although no-one in the family is yet elderly, the high lintel to the blue house; multiple hose pipes, and an uneven climb to the kitchen and dwellings impeded mobility. And climbing up to the temporary storage room above the blue house was dangerous (climbing up of a chair).

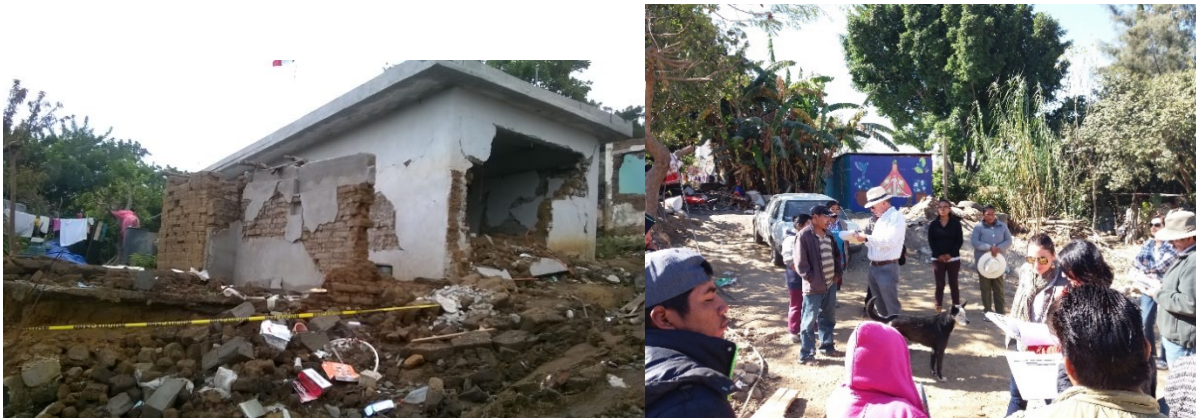
Photograph 4.4 (left): Earthquake damage to consolidated adobe walled house (Image taken by Alejandro Luna López). Photograph 4.5 (right), Members of the FCP on site to discuss plans for new homes with Doña Francisca's family (see also Appendix. 4 Case 2a <https://lahn.utexas.org/Puebla/App4.html>) (Image taken by Alejandro Luna López)

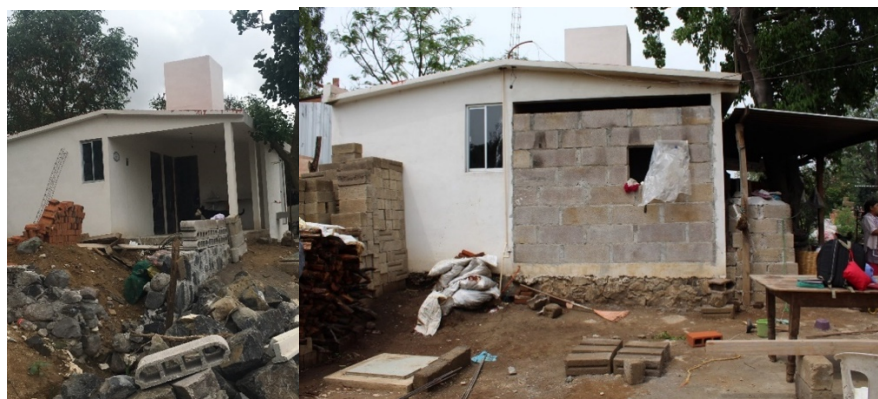
Photograph 4.6 (left): Lidia's house in March 2018. Photograph 4.7: in July 2019 showing enclosure of the patio (now a dining/living area). (Both images taken by Dr. Peter Ward.)

The self-help modifications to the FCP dwelling suggests that the FCP's premise of an open patio in which to cook was misconstrued since families continue to cook outside using wood, and until they choose or can afford propane gas (tanks) they are unlikely to move to an inside kitchen. Thus, the FONDEM designs seem better designed. In a later section we will examine the health challenges presented by both the new and the older traditional housing structures.

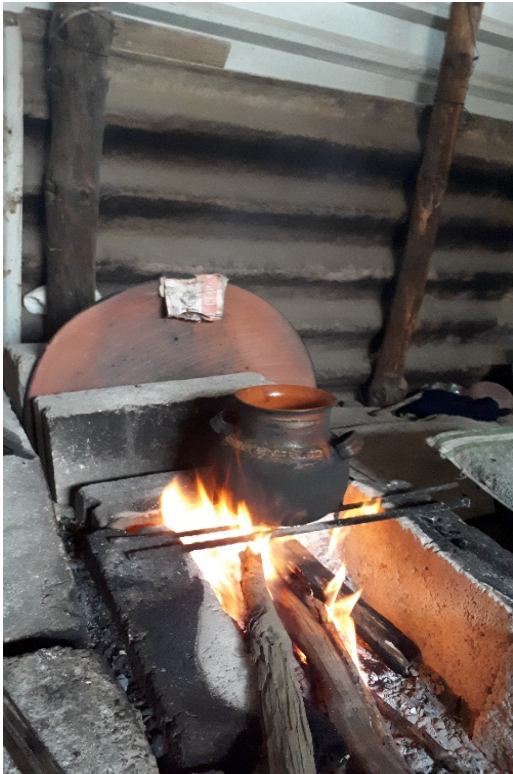
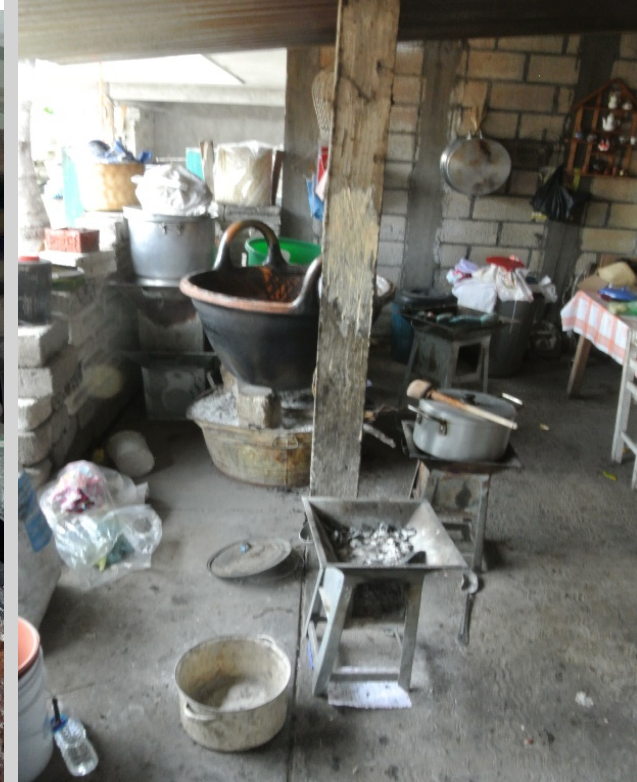
Photograph 4.8 (top): Typical wood fire in outdoor kitchen. Photograph 4.9 (below): Large bowl set above a wood fire (for *mole*) and small stoves for carbon and heating *tortilla* (Images by Dr. Peter Ward).

Because the majority of households in rural pueblos cook with wood (*leña*) especially and *carbon* for tortilla stoves (see Figures 4.8 & 4.9 below), kitchens and cooking spaces are often outside or adjacent to main dwelling and living spaces, and are especially likely to be made of lámina, sometimes open on one side and giving out onto the patio (see photos in Appendix 4. Case 5a). Even if partially open on one side, if good ventilation is not assured, then very poor or even hazardous air quality may ensure (see below and Appendix. 4 Case 1a & 1cd).

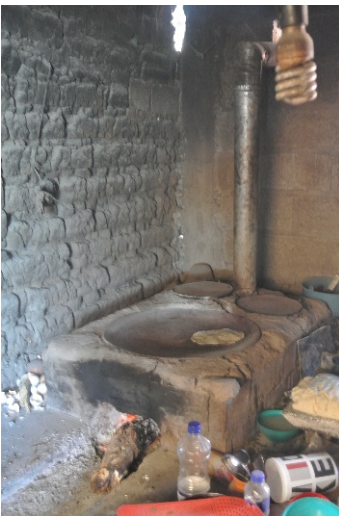
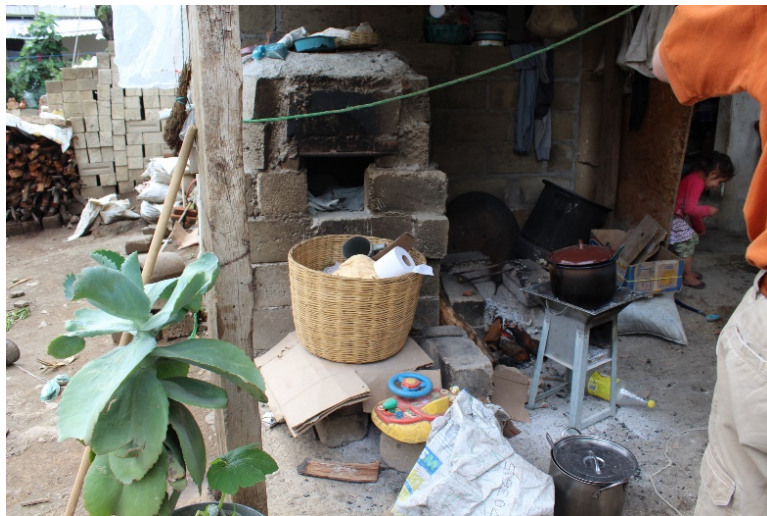
Photograph 4.10: Wood fire *comal* and chimney. Photograph 4.11: Wood fire oven with small stove and coal (Images by Dr. Peter Ward).

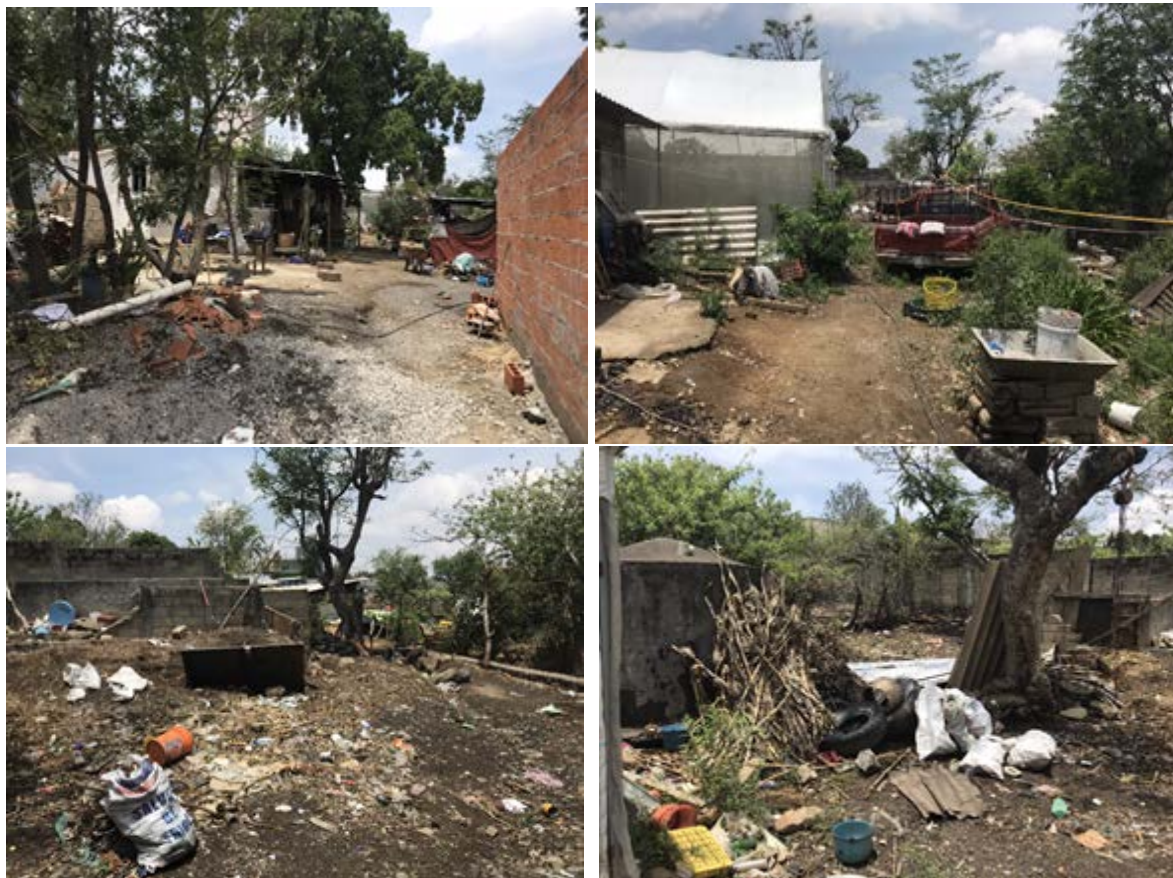
Photographs 4.12a-d: Images from Case 2 showing garbage and hazards to mobility (Images taken by Dr. Peter Ward). See also Appendix 4. Case 2b.

In addition to the air quality problems that this case presents we can point to several other health issues in this micro-environment. Uneven surfaces and the hose pipes and building materials lying around the front half of the lot impedes mobility, and are especially hazardous for young children as well as the elderly (see photos in Photographs 4:12a-b). Uneven ground and entrance (to Francisca's house) would also likely to cause trips and impede mobility. Lidia is heavily overweight and appears to be in very poor health (diabetes?). The kitchen area is bare earth and combined with the dirty lot areas could be a source of infectious diseases.

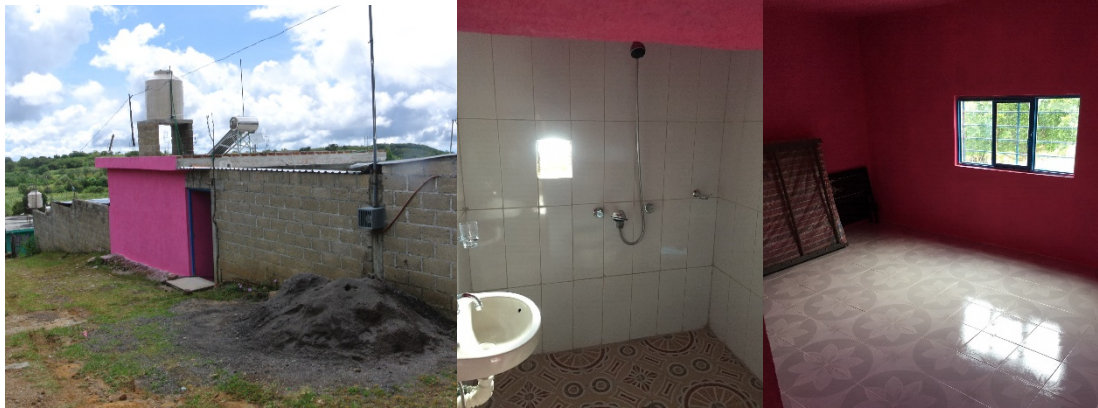
Photographs 4.13a-c: Additions to Manuel's home July-October 2019: Solar panel water heater; new bathroom and "sala/bedroom"
